## The Grape store

In 2021 an old shed was restored at Northfield allotments, with thanks to the plot holders for allowing it to be restored.

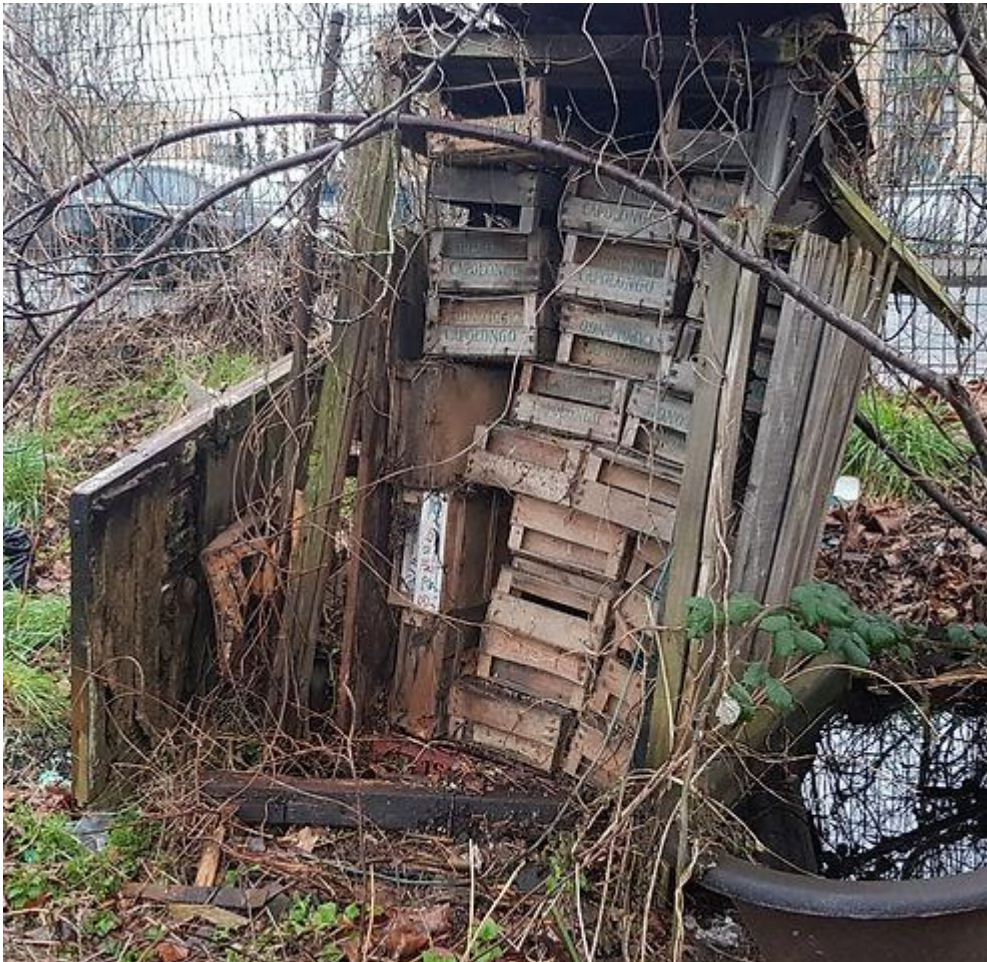
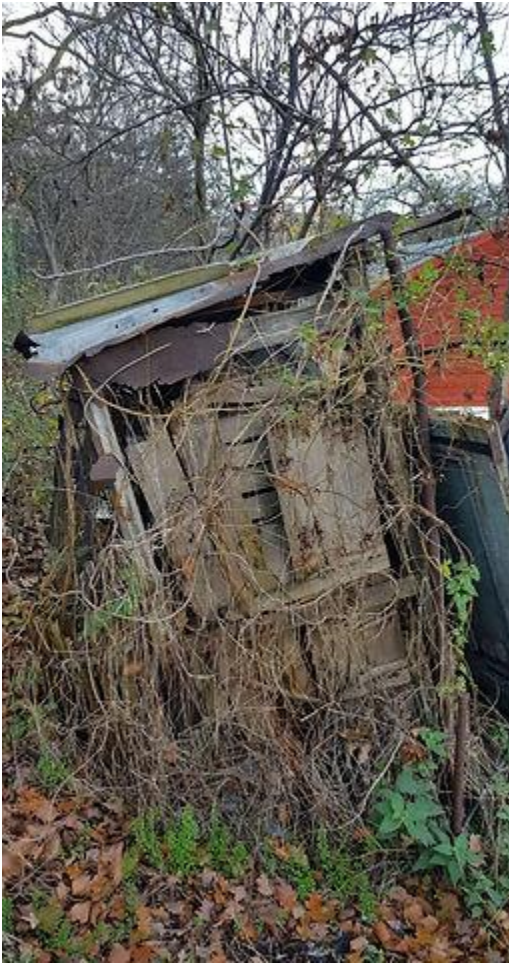
The restoration of the store was carried out in March 2021. The images below were taken in late 2020 and early 2021 and show the shed in poor condition.

**Structure:** The structure leant backwards, which may have been caused by the weight of the metal roof.

**Door:** The door was not attached and can be seen leaning against at the side of the shed. The four panelled door details were hidden by various pieces of wood used to strengthen it by a previous plot holder. This additional wood was very rotten and had added to the level of fungus attacking the door. The wood worm and rot had created a habitat for worms, woodlice and slugs. When the door was rebuilt, around 40 percent of the wood was too rotten to reuse.

**Door:** The front door was a great surprise to me, although it had been covered with various pieces of wood that disguised its beauty. The door was particularly rotten and the bottom 2ft was missing, and really only the top section and the latch stile were reusable. I was able to get a reclaimed Edwardian door and completely rebuilt this door. The image below shows some new lower sections added to the original upper sections. The new door sections were repainted on the outside to match the original paint.

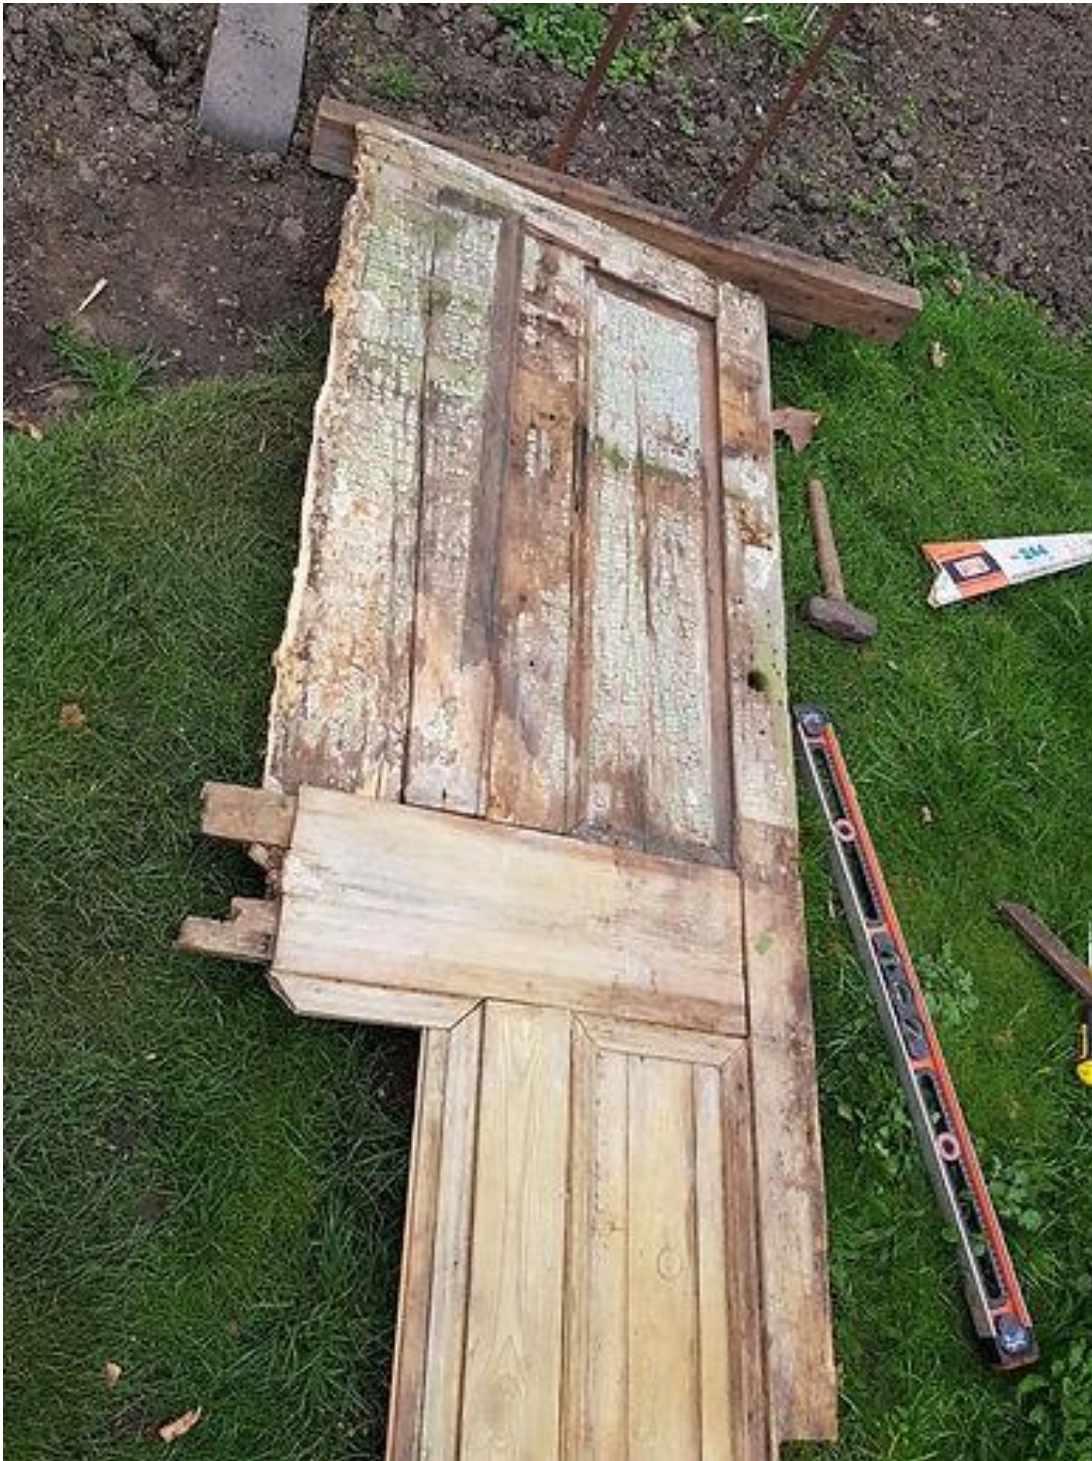
Above left: the front door being rebuilt, Above right the shed rebuilt

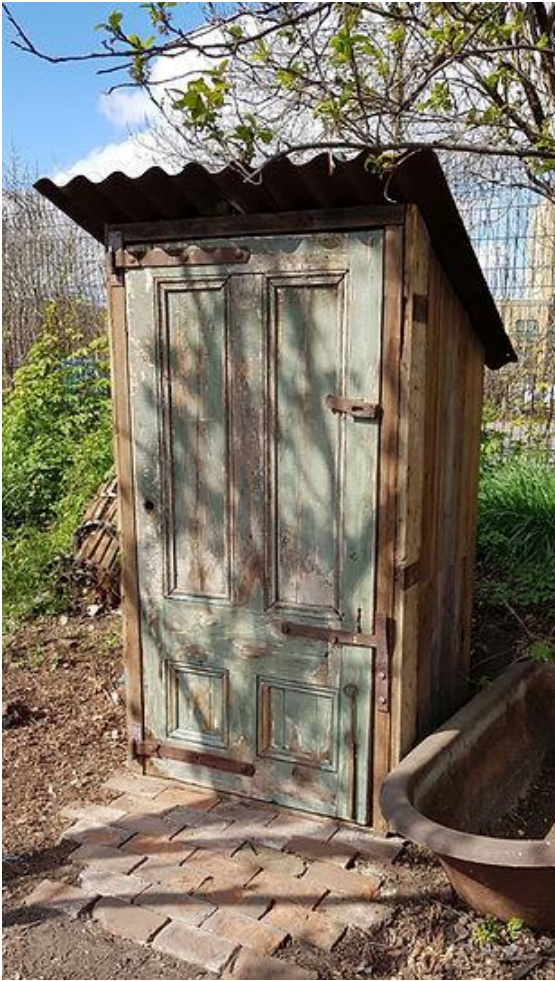
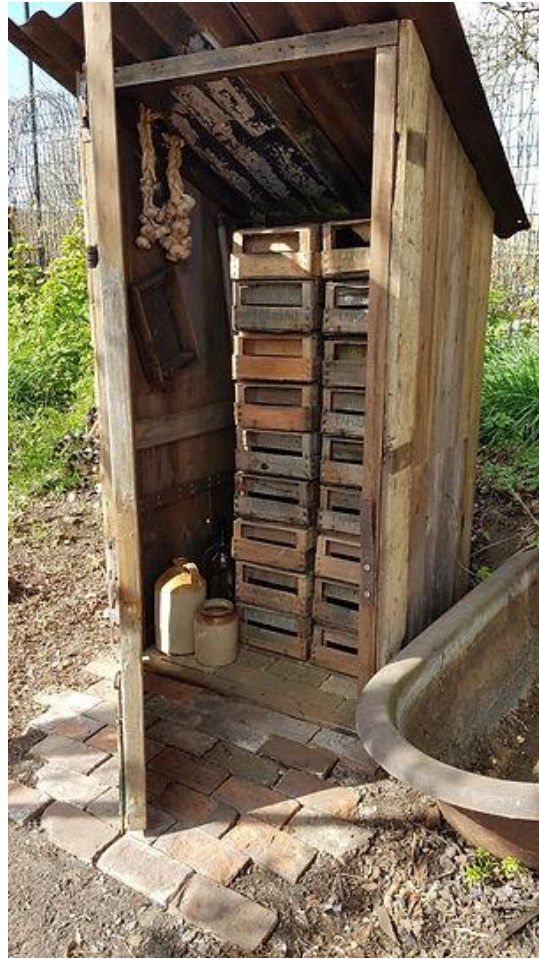
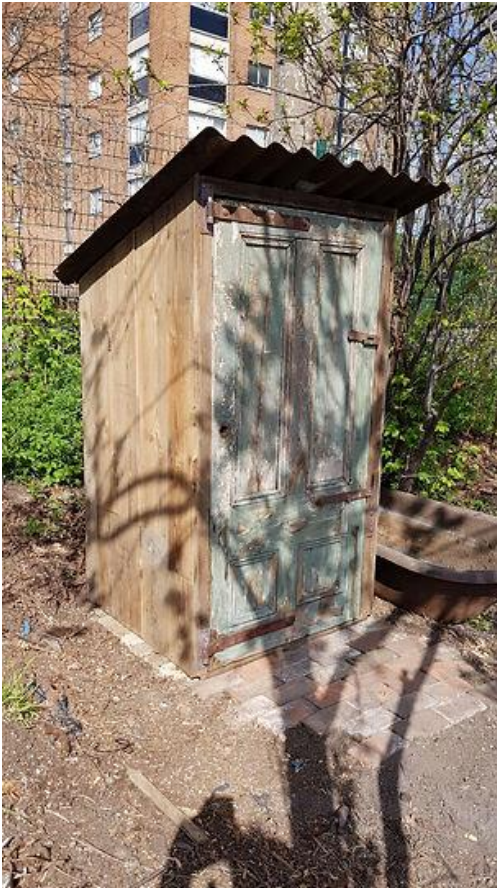
Above: the completed Grape store with rebuilt door, Inside you can see the grape boxes and some vintage items. You can see this and other heritage features during our summer open day.

**Ironwork:** The top hasp was kept on the door. A new pair of reclaimed hinges were used to replace ones which were not particularly old. I added a door latch made from metal from the allotment and a rather interesting barrel bolt made from a brass barrel and metal pin found on the allotment. I also added a few items inside which I have collected during my time on the allotment.
